REPORT DOCUMENTATION PAGE		READ INSTRUCTIONS BEFORE COMPLETING FORM
1. REPORT NUMBER	2. GOVT ACCESSION NO.	3. RECIPIENT'S CATALOG NUMBER
	AD-A092	296
4. TITLE (and Subtitle) Phase I Inspection Report Patterson Brixus Grey Creek Watershed Project, Site I Susquehanna River Basin, Broome County, New York Inventory No. 698		5. TYPE OF REPORT & PERIOD COVERED Phase I Inspection Report National Dam Safety Program

19. KEY WORDS (Continue on reverse side if necessary and identify by block number) Dam Safety National Dam Safety Program Visual Inspection Hydrology, Structural Stability Patterson Brixus Creek Watershed Project, Site I Broome County Patterson Creek

Photo #1
Overview of Patterson Brixius Site 1 Dam

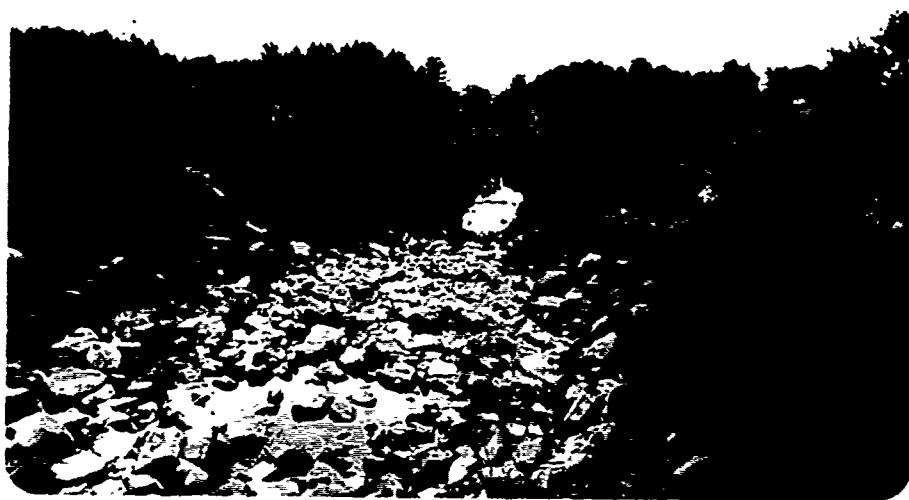
The downstream channel below the impact basin is ripraped. Some vegetation was observed along the banks of this channel. (Photo #4)

Photo #4
Downstream Channel

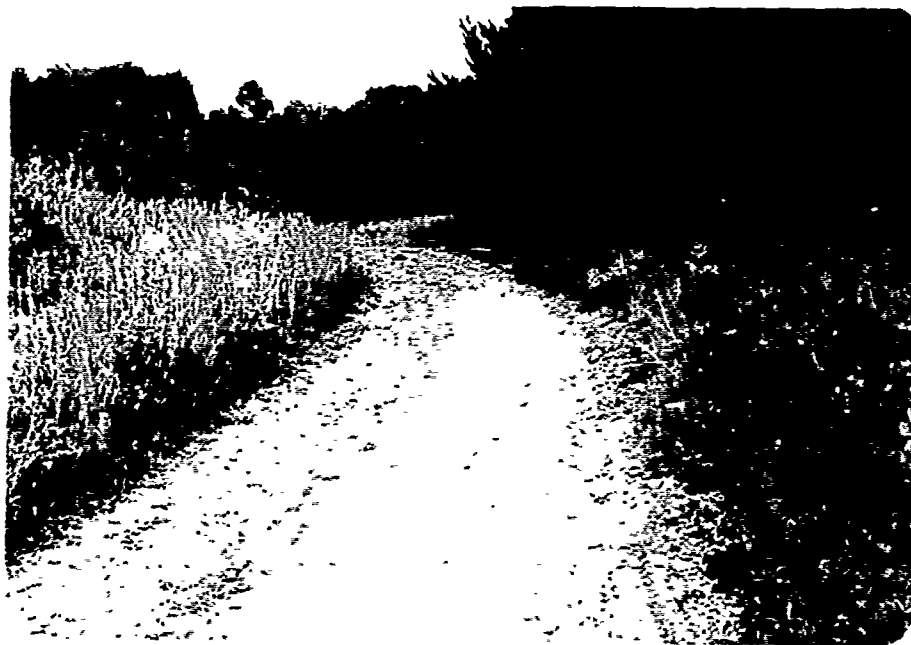
Pedestrian and vehicular paths were noted on the crest and slopes of the embankment. These paths are a potential source of erosion. (Photos 5 & 6)

Photo #6
Downstream Face - Left Abutment

1. Eliminate the pedestrian and vehicular traffic on the embankment and auxiliary spillway, backfill all depressions and reseed these areas.
2. Repair the erosion and reseed the areas adjacent to the impact basin, at the toe of the right abutment, and the regraded area between the right abutment and the outlet of the auxiliary spillway. Also remove the stockpiles of soil in the auxiliary spillway channel and channel outlet, and reseed.
